DEPARTMENT OF NATURAL RESOURCES
DIVISION OF OIL, GAS AND MINING

RE: Technical Field Visit to the #1 Mine Site, Plateau Mining Corporation, Star Point Mine, C/007/006

The purpose of the field visit was to observe installation of Pyramat in the drainages and to sample the graded surface soils of the Lion's Deck.

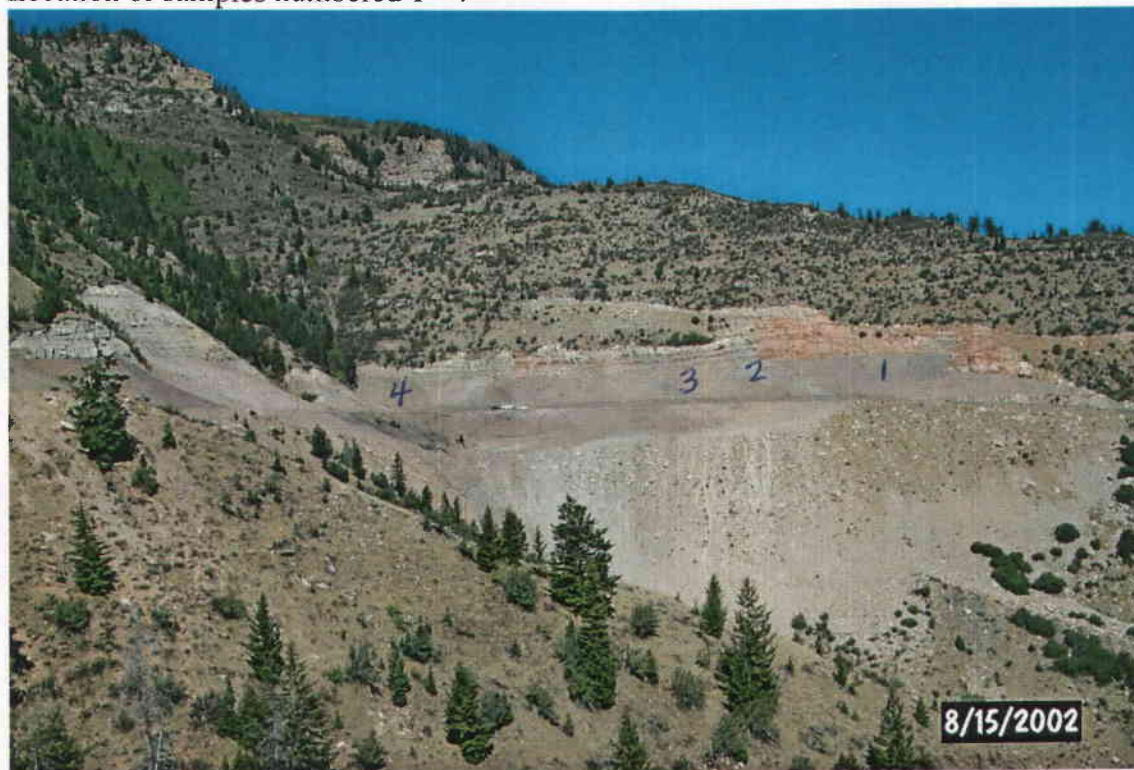
The Lion's deck has been backfilled with approximately 100,000 cubic yards of mine waste from the main drainage. The mine waste was covered with four feet of clean fill from the outcrops of the Lion's Deck, approximately 50,000 cubic yards of fill was utilized. Nine samples were taken from the site. Sample locations are identified on the attached photos #P0003737 and P0003714. The characteristics of the surface soils are outlined in the table below.

Location of samples numbered 1 - 4

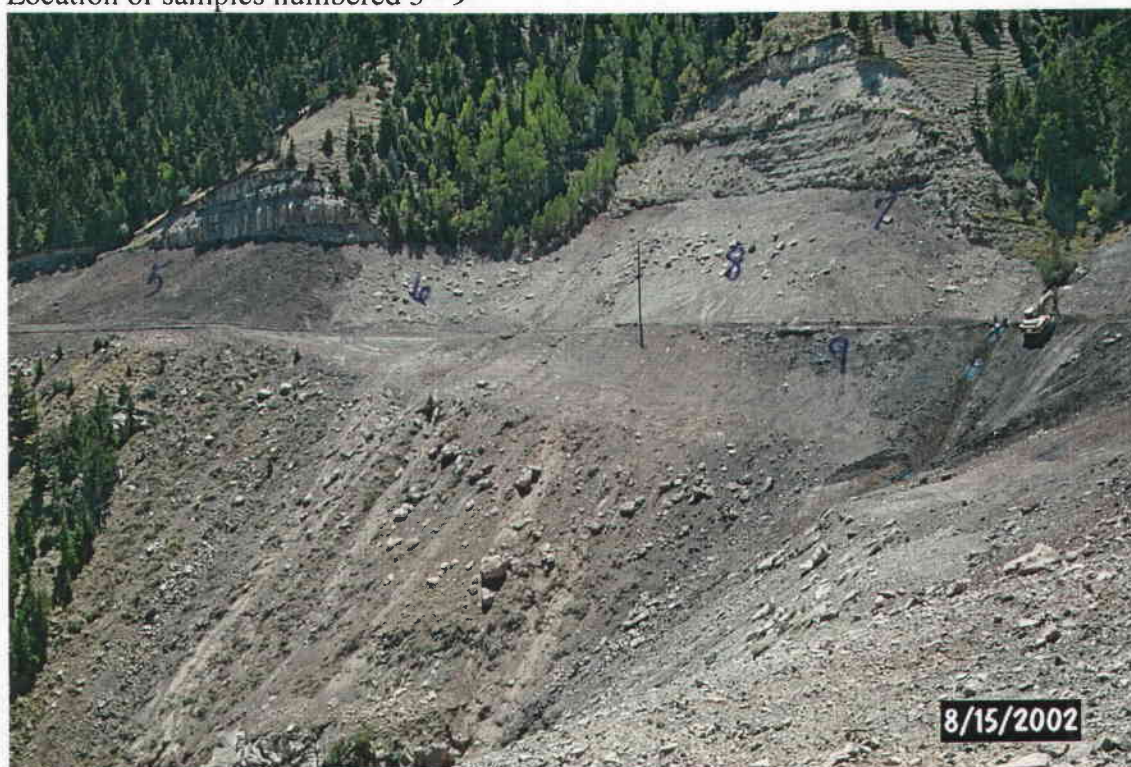
Location of samples numbered 5 - 9
